U. S. DEPARTMENT OF AGRICULTURE,
FOREST SERVICE—Circular 198.

CONDITION OF EXPERIMENTAL CHESTNUT POLES IN
THE WARREN-BUFFALO AND POUGHKEEPSIE-
NEWTON SQUARE LINES AFTER FIVE
AND EIGHT YEARS' SERVICE.

CARLILE P. WINSLOW,

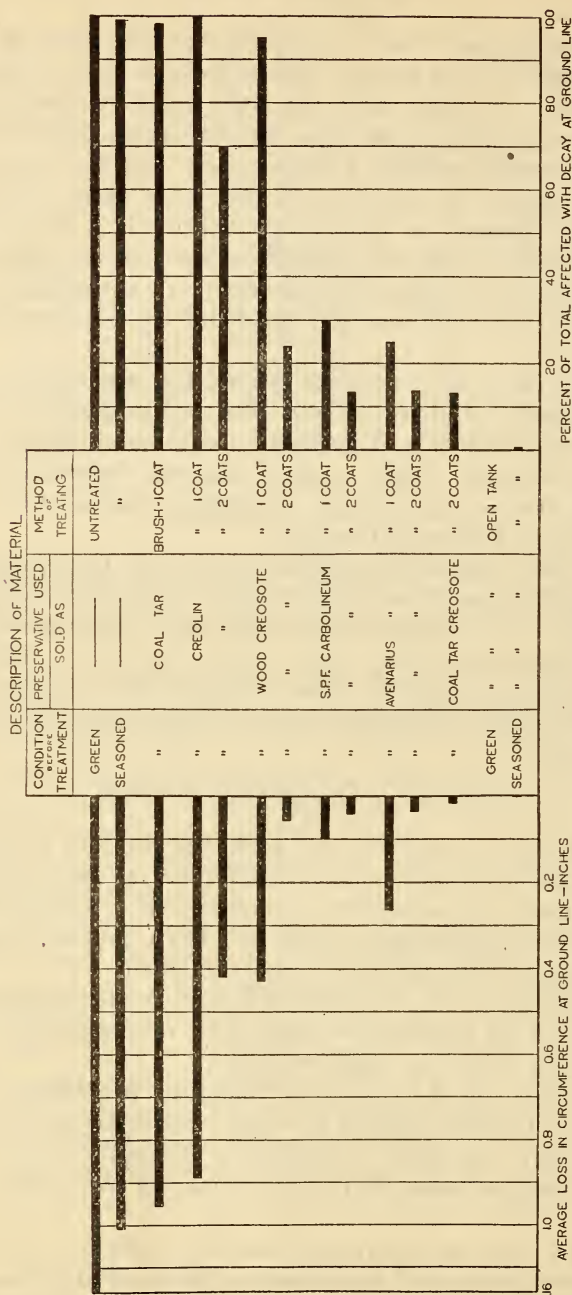
Table 3 gives, for each class of poles, the per cent affected with decay and the average loss in circumference at the ground line. Figure 1 presents the same data in graphic form. The more significant results are summarized on page 12. For a proper valuation of these results the following points should be noted:

Fig. 1.—Condition of experimental poles in Warren-Buffalo line 5 years after placement.

(1) Both the green and seasoned poles butt-treated with coal-tar creosote by the open-tank process showed practically no decay at or near the ground line.

(2) The poles brush treated with two coats of coal-tar creosote, and preservatives sold as Avenarius carbolineum, S. P. F. carbolineum, and wood creosote, showed but little difference in the extent of decay. Their average loss of circumference was 0.02, 0.04, 0.04, and 0.06 inch, and the per cent affected with decay 14.5, 13.6, 13.4, and 24.0, respectively. The condition of these poles was next best to that of those treated with coal-tar creosote in the open tank.

(3) The poles brush treated, respectively, with one coat of preservatives sold as S. P. F. carbolineum and Avenarius carbolineum showed a much greater loss of circumference at the ground line than those treated with two coats of these preservatives. The average losses of circumference were 0.10 inch and 0.27 inch, and the per cent affected with decay 30 and 25, respectively.

(4) The poles brush treated with two coats of preservative sold as creolin and those similarly treated with one coat of preservative sold as wood creosote showed but slight difference in loss of circumference at the ground line, the average loss being 0.42 and 0.43 inch, and the per cent affected with decay 69.8 and 95.2, respectively.

(5) The poles brush treated, respectively, with one coat of preservatives sold as creolin and coal tar, showed a loss of circumference at the ground line of 0.89 and 0.95 inch, and a per cent affected with decay of 100 and 98, respectively. The loss with these poles was nearly as great as with the untreated.

(6) The untreated poles were practically all more or less affected with decay at the ground line, the average loss of circumference for those seasoned prior to placement being 1.01 inches, and for those placed green 1.16 inches. That two of those seasoned prior to place-

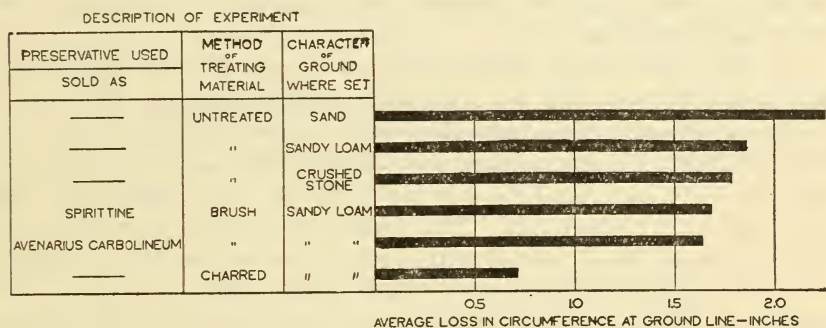
The results from this experimental line are not as conclusive as those from the one just described. Only 72 poles were placed, and records showing the details of their preparation and treatment are not available. Table 4 gives the number of poles of each class and their average loss of circumference at the ground line. Figure 2 shows the same data in graphic form.

FIG. 2.—Condition of experimental poles in Poughkeepsie-Newton Square line 8 years after placement.

(1) The untreated poles set in crushed stone showed less decay at the ground line than similar poles set in sand, the average loss of circumference at that point being 1.77 inches and 2.27 inches, respectively.

(2) The poles with charred butts showed less decay at the ground line than similar uncharred and untreated poles set in either crushed stone or sand, their average loss in circumference at the ground being only 0.71 inch.
